**Impervious Cover Assessment
for
Manville Borough, Somerset County, New Jersey**

*Prepared for Manville Borough by the
Rutgers Cooperative Extension Water Resources Program*

February 6, 2015

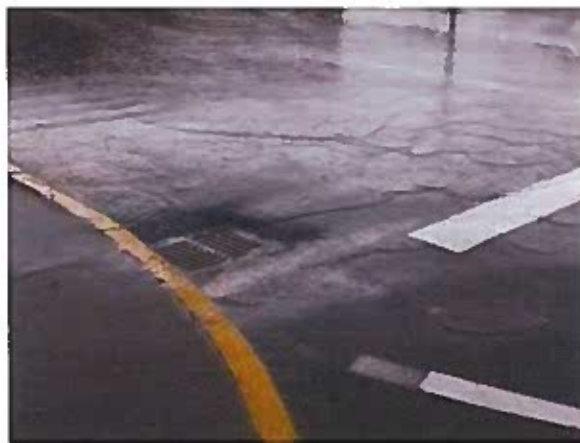
Figure 1: Stormwater draining from a parking lot

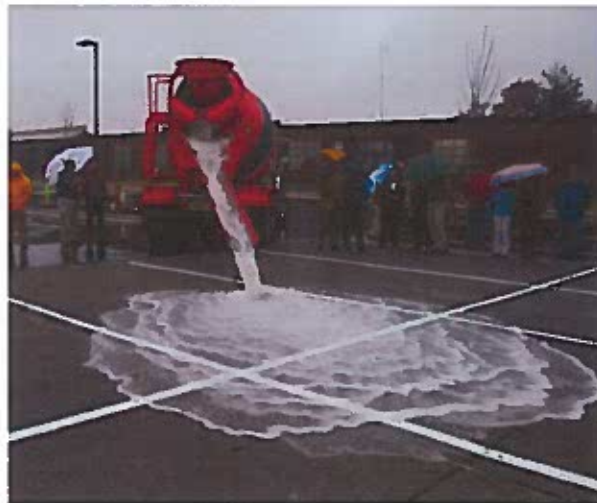
Figure 2: Rapid infiltration of water through porous pavement is demonstrated at the USEPA Edison New Jersey test site

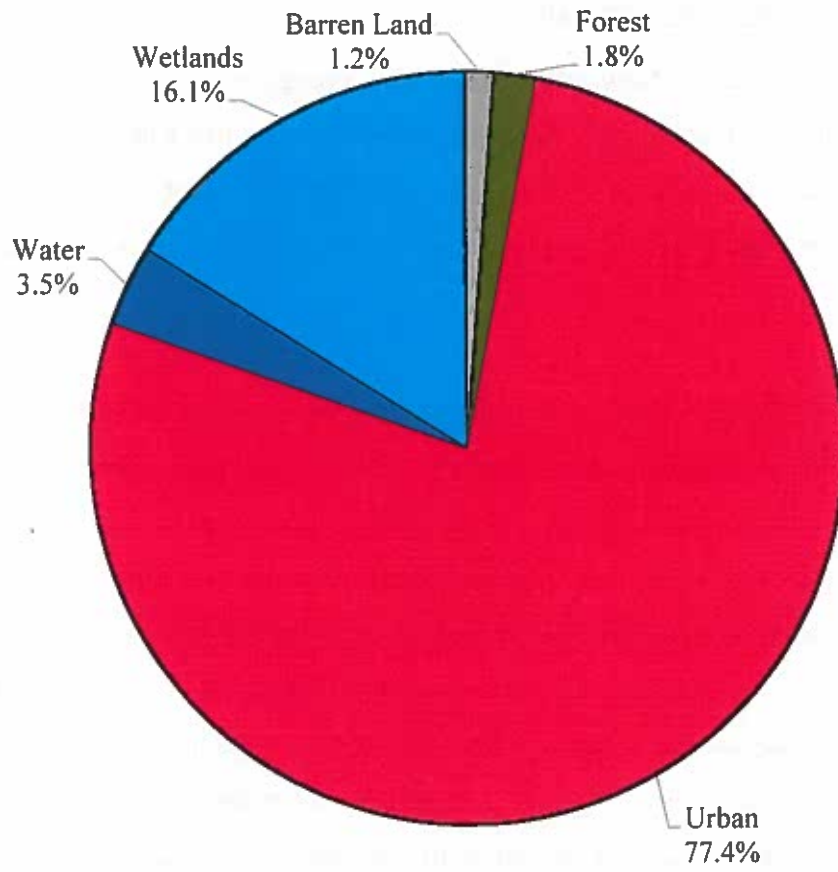
Figure 3: Pie chart illustrating the land use in Manville Borough

Located in Somerset County in central New Jersey, Manville Borough covers approximately 2.45 square miles south of Bridgewater Township. Figures 3 and 4 illustrate that Manville Borough is dominated by urban land uses. A total of 77.4% of the municipality's land use is classified as urban. Of the urban land in Manville Borough, medium density residential is the dominant land use (Figure 5).

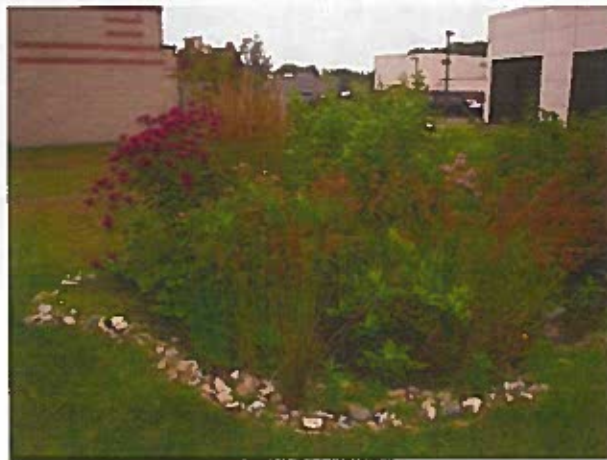
Figure 7: Rain garden outside the RCE of Gloucester County office which was designed to disconnect rooftop runoff from the local storm sewer system

- **Rain Gardens:** Stormwater can be diverted into shallow landscaped depressed areas (i.e., rain gardens) where the vegetation filters the water, and it is allowed to soak into the ground. Rain gardens, also known as bioretention systems, come in all shapes and sizes and can be designed to disconnect a variety of impervious surfaces (Figure 7).

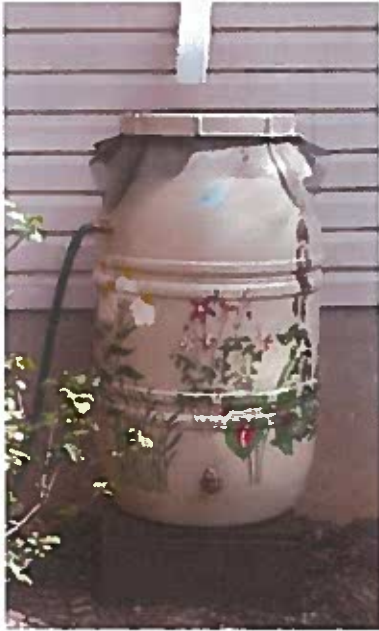
Figure 8a: Rain barrel used to disconnect a downspout with the overflow going to a flower bed

- **Rainwater Harvesting:** Rainwater harvesting includes the use of rain barrels and cisterns (Figures 8a and 8b). These can be placed below downspouts to collect rooftop runoff. The collected water has a variety of uses including watering plants and washing cars. This practice also helps cut down on the use of potable water for nondrinking purposes. It is important to divert the overflow from the rainwater harvesting system to a pervious area.

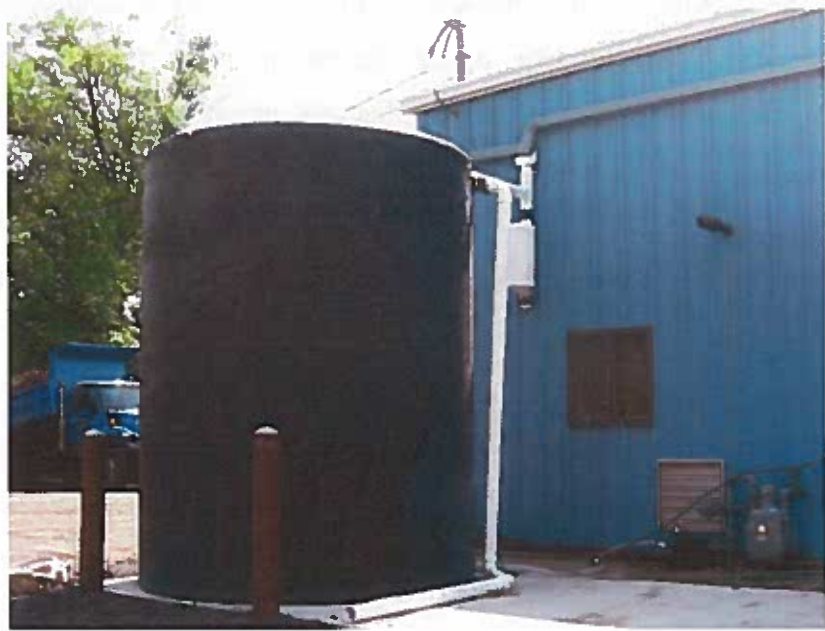
Figure 8b: A 5,000 gallon cistern used to disconnect the rooftop of the Department of Public Works in Clark Township to harvest rainwater for nonprofit car wash events
